# **2020 Peninsula Lake Stream Data Collection**

**In Accordance with The Peninsula Lake Association**

**Co-op Assignment- Fish and Wildlife Technology**

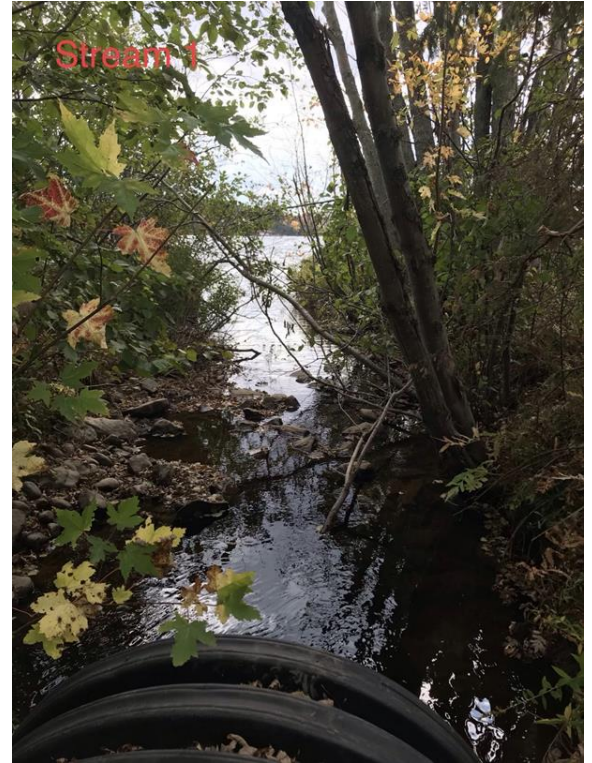
## Stream 1:

**Debris:** There were a few large rocks and trees covering the stream; however, the stream was not blocked.

The opposite can be seen in stream 1, the velocity is at 17.27 liters per second but the overall flow rate is only at 14.4 liters per second. This is because the stream is very shallow and narrow, so even though the water is moving fast, the overall flow rate is less.

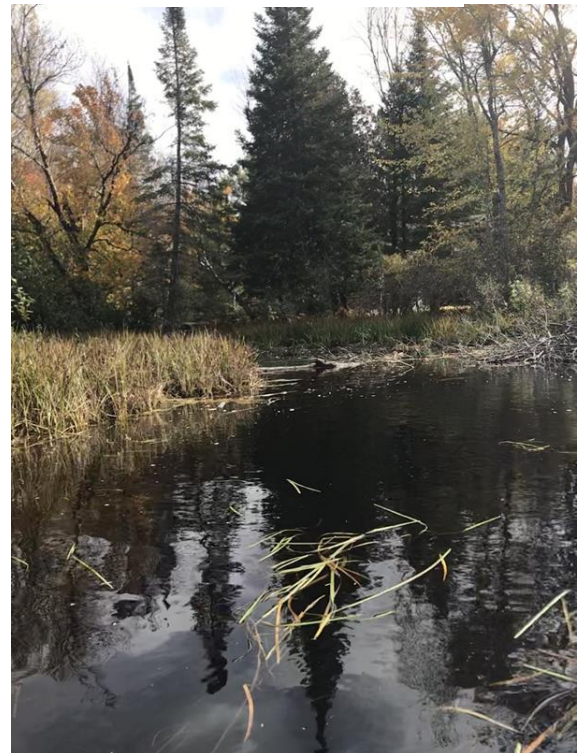
## Stream 2:

**Debris:** There is a beaver den on the right bank of the stream and a few logs obstructing access; however, the blockage is very minimal and is not greatly impacting the flow of the stream.

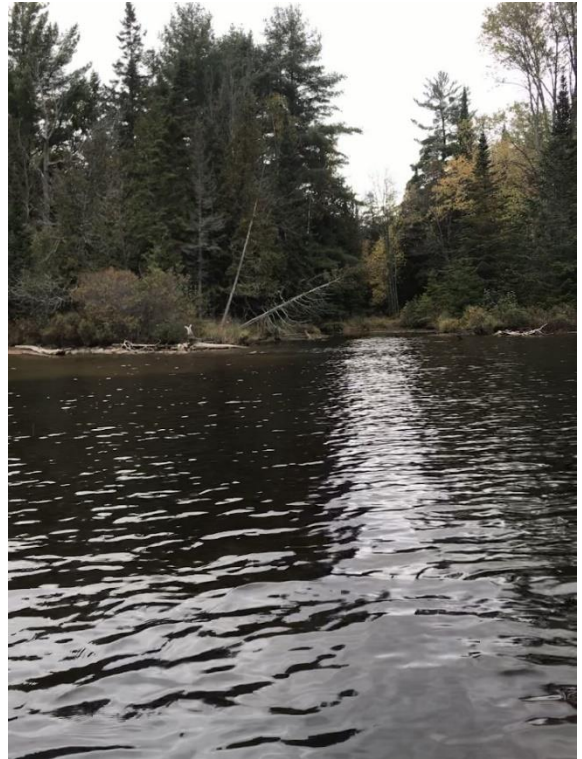
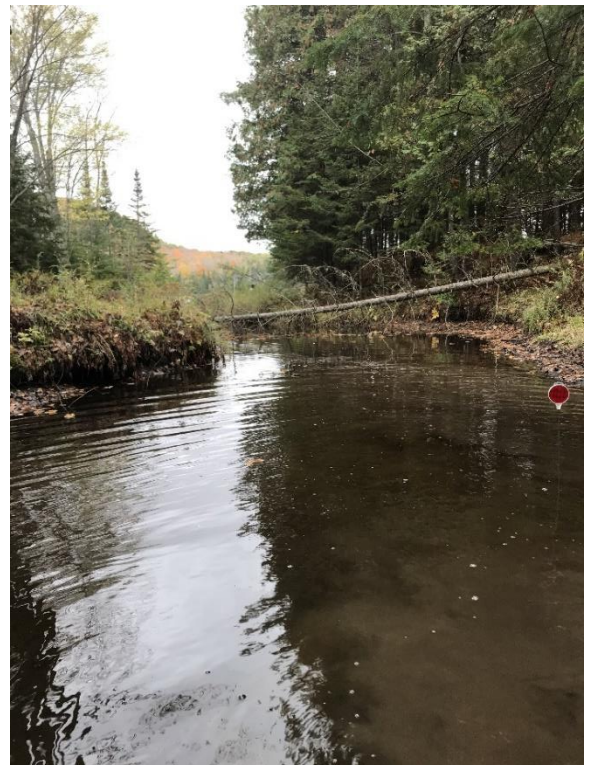
### Stream 3:

**Debris:** There were a few logs and trees over the stream but it seemed to have very little effect on the flow rate of the stream.

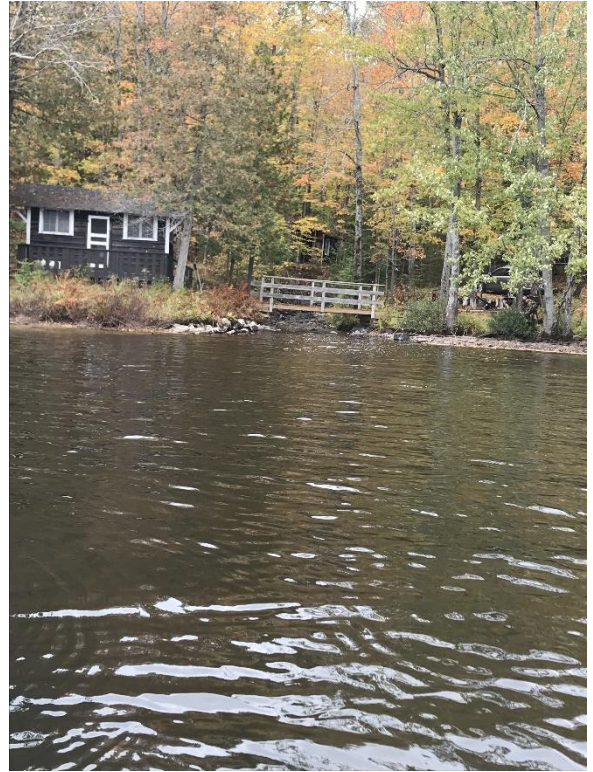
## Stream 4:

**Debris:** Multiple rocks and logs were present; however, they did not impede on stream flow

**Note:** Flowrate was measured closer to the mouth of the stream because of the steeper incline and faster flow rate.

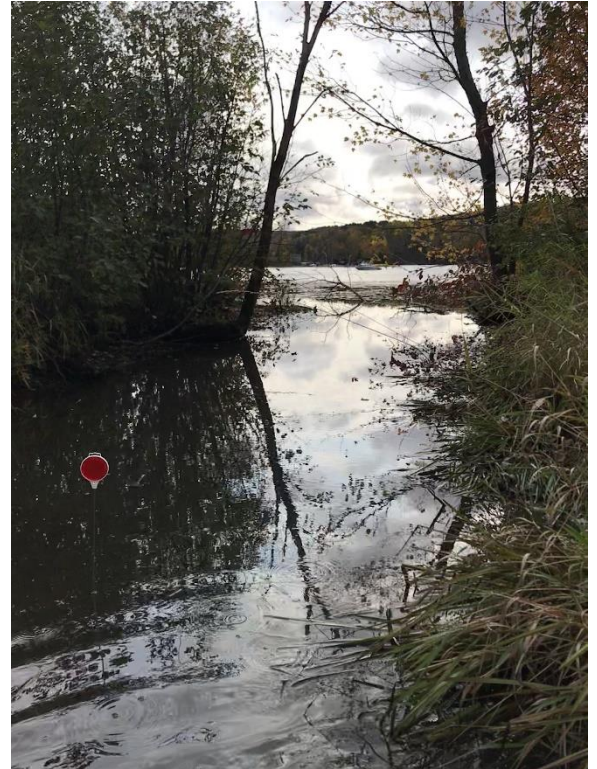
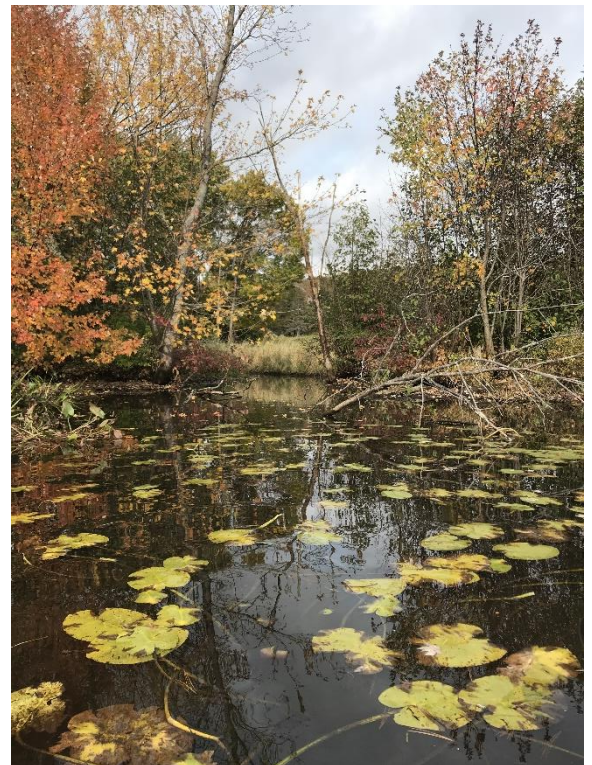
## Stream 5:

**Debris:** There were a few fallen trees and some thick vegetation.

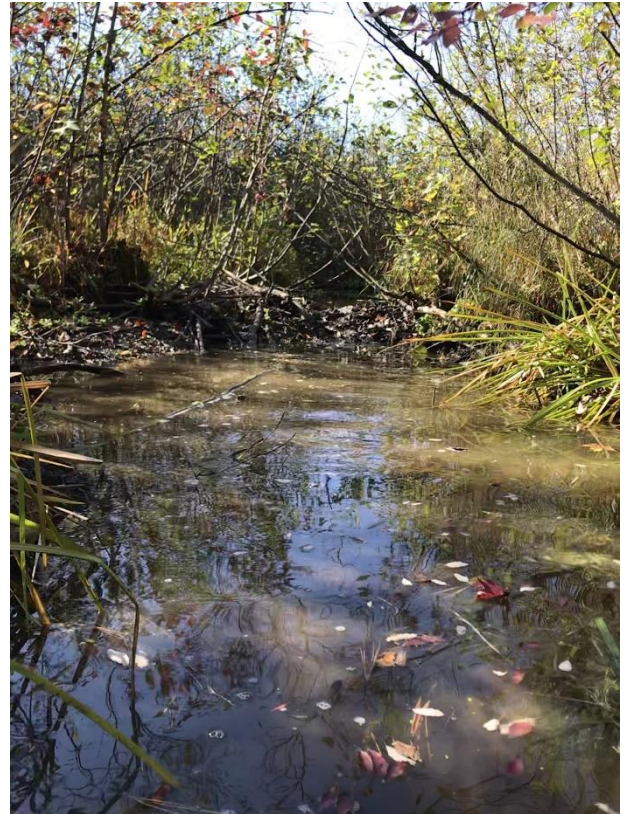
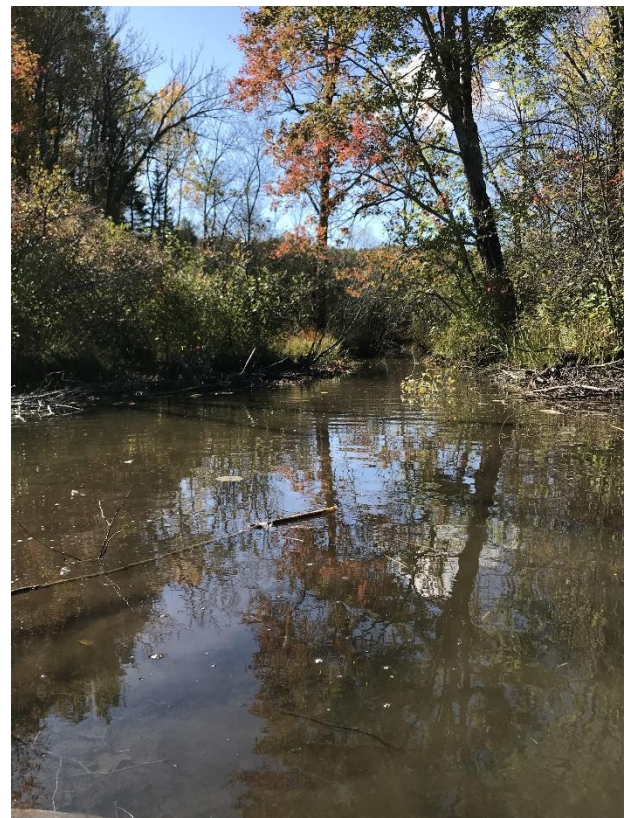
## Stream 6

**Debris:** There were a few logs and branches covering the stream, but the most prominent obstructions were the multiple beaver dams blocking the stream. The beaver dams attributed to an unmeasurable flowrate.

**Notes:** Noticeably foul odour at stream site.

Stream 6 was seemingly still standing, so much so that macrophytes such as Duckweed, that prefer still water, was present. The stillness of the water could be explained by the series of beaver dams obstructing the flow of the stream.

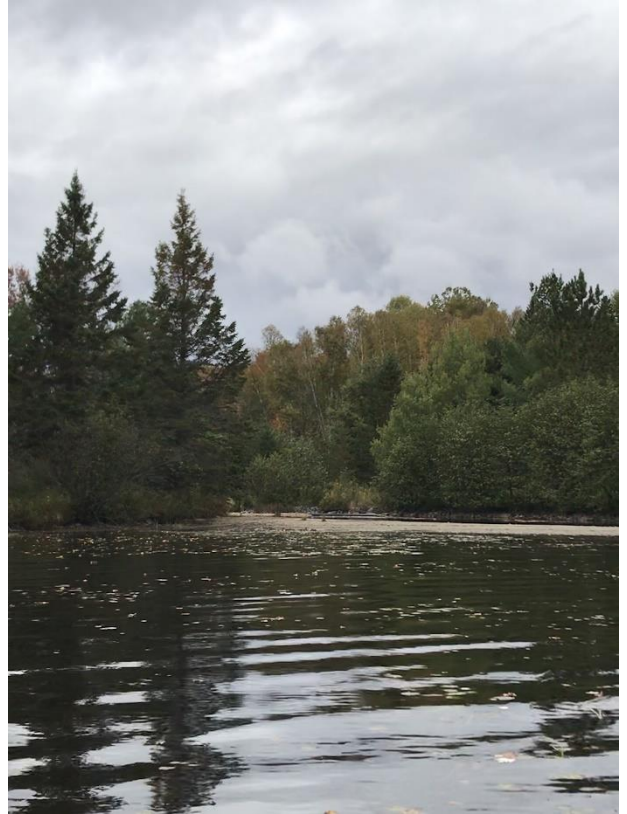
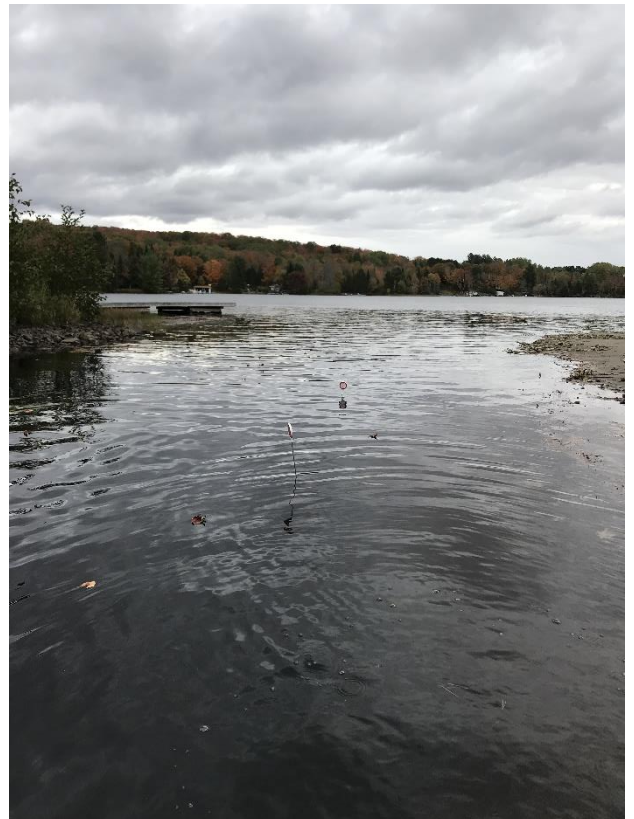
## Stream 7:

**Debris:** There was no debris blocking the flow of this stream.

Overall, stream #7 had the highest flow rate at 710 liters per second. However, it had a significantly lower velocity than most of the other streams. The velocity of stream 7 may be slow but the stream is very wide and deep which allows for a much larger overall flow rate.

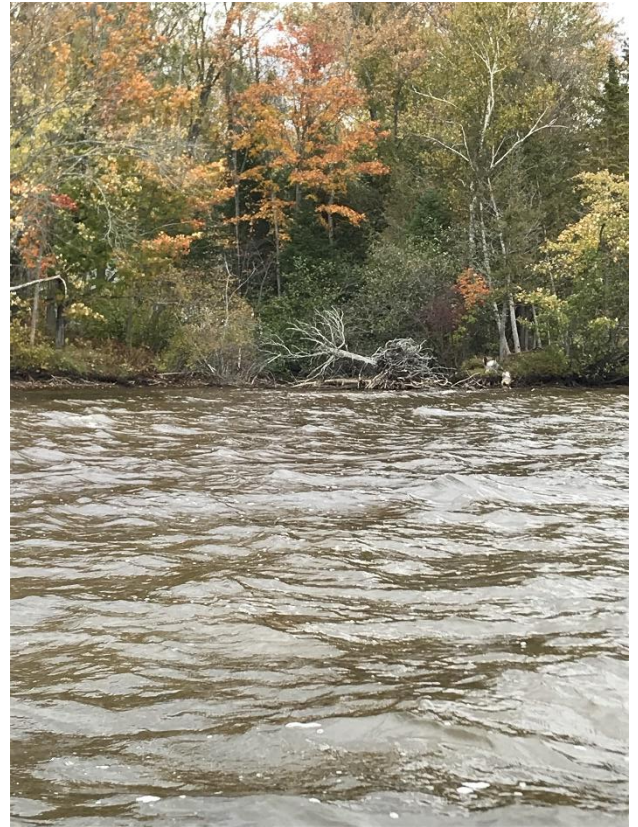
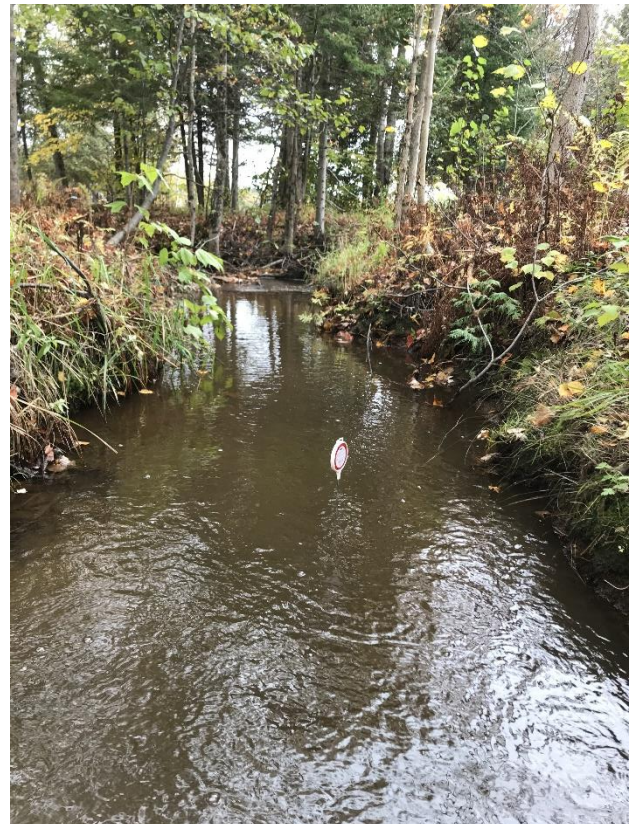
## Stream 8:

**Debris:** There were a few fallen trees and logs obstructing the stream; however, they did not impede on the stream flow.
