Peninsula Lake - Lake Level Report

June 23, 2015

Provided by Muskoka Watershed Council

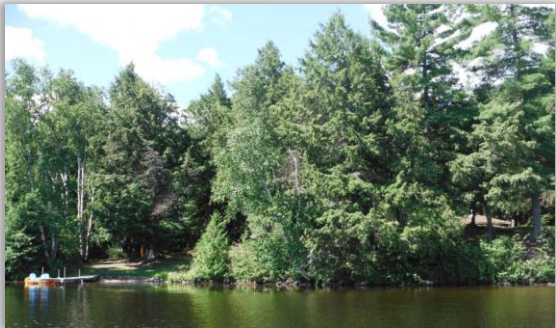
Class & Description	Photograph Example*
<p>Natural – A healthy buffer of vegetation and/or a natural shoreline of sand or exposed rock that is undisturbed and undeveloped.</p>

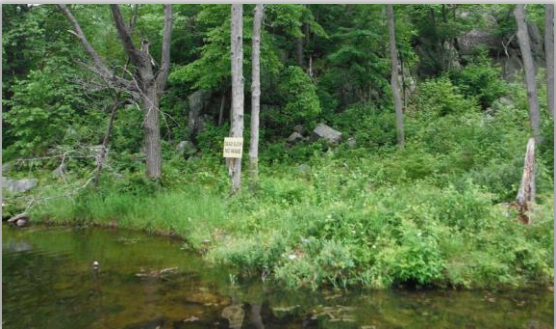
<p>Regenerative – Natural vegetation has been removed in the past, but is in the process of growing back towards a natural state.</p>

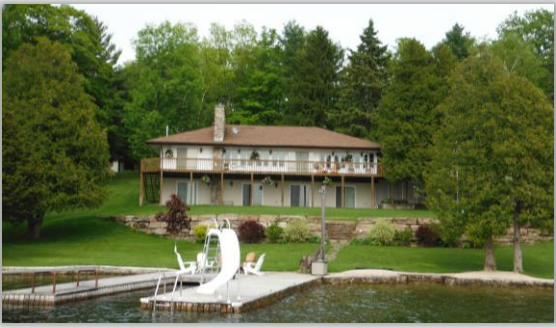
<p>Ornamental – All natural vegetation has been removed and replaced with mowed lawn and other non-native vegetation; structures such as docks, decks, boathouses and boat ramps are predominantly present at the shore.</p>

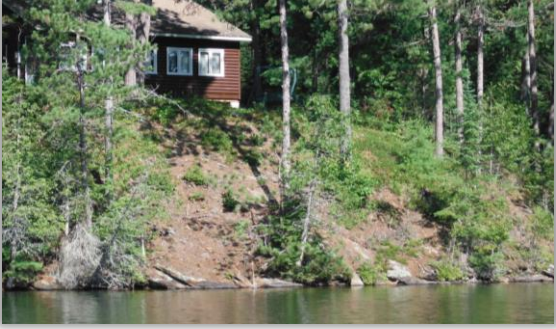
<p>Degraded – Natural vegetation has been lost; soil erosion, undercutting of the bank, and/or exposed roots of shrubs and trees are significant.</p>

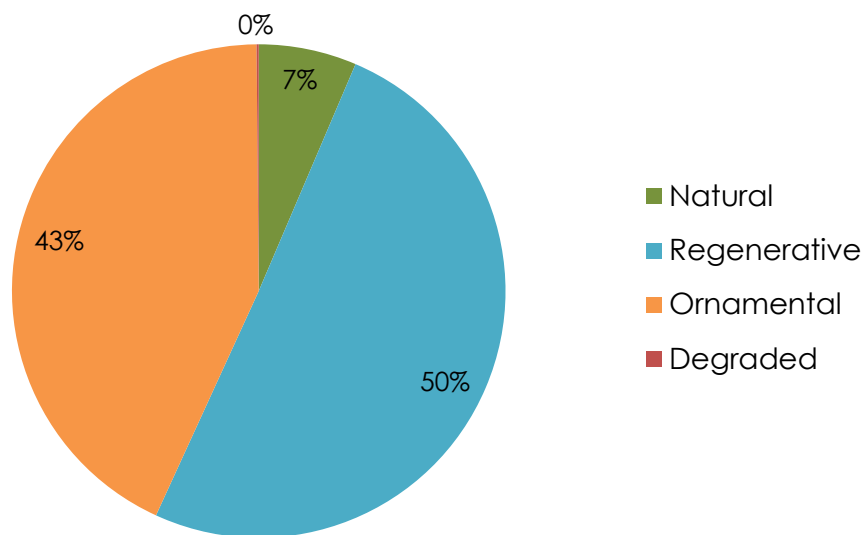
- 1,694.11 metres or 6.5% natural;
- 13,140.39 metres or 50.3% regenerative;
- 11,213.53 metres or 42.9% ornamental; and
- 37.30 metres or 0.14% degraded.

Figure 1 shows the percentage of the entire assessed shoreline in each classification. Figure 2 shows the percentages of each shoreline class per property. The overall estimated length and percentage of shoreline development on Peninsula Lake is 6,360.42 metres or 24.33%. The overall estimated length and percentage of retaining walls on Peninsula Lake is 4,340.52 metres or 16.6%. Table 2 summarizes these results.

Figure 1. Total classification percentages of all assessed shoreline properties on Peninsula Lake.

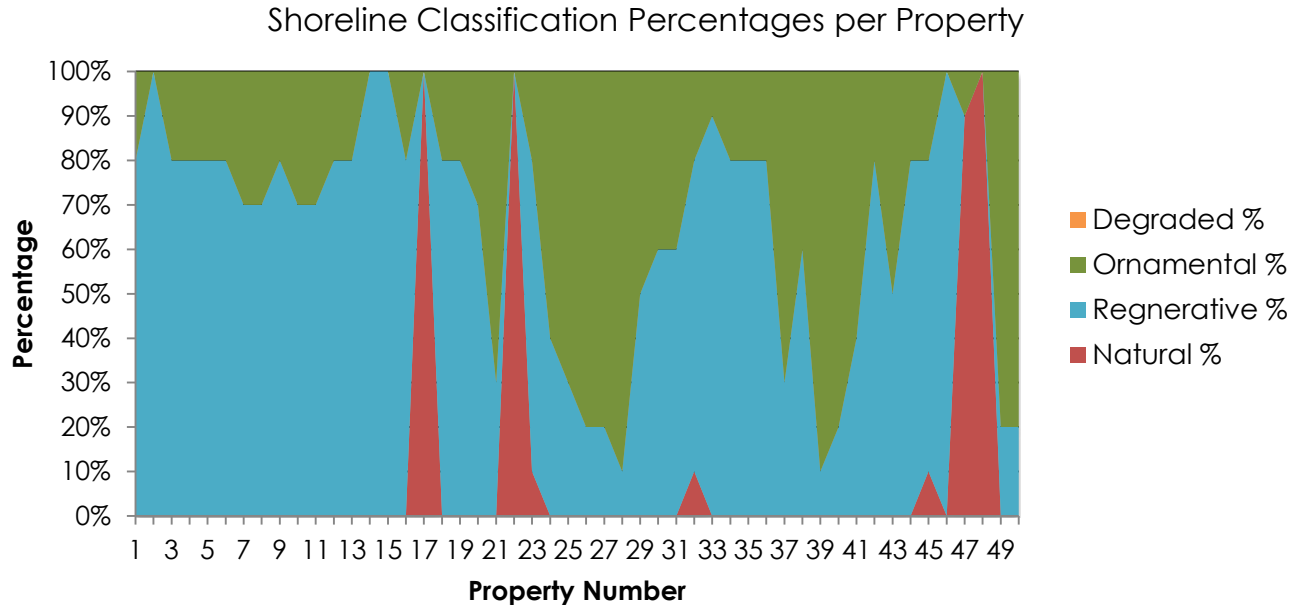
Figure 2. Classification percentages per property of all shoreline properties assessed on Peninsula Lake.

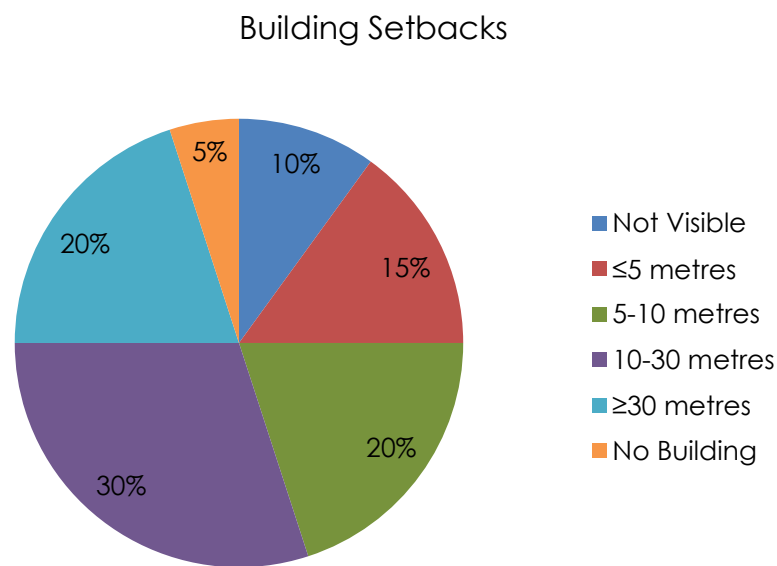
- 2 properties, or 1% of properties assessed, had building setbacks that were not visible;
- 9 properties, or 3% of properties assessed, were less than or equal to five metres from the shoreline;
- 27 properties, or 8% of properties assessed, were between five and 10 metres from the shoreline;
- 110 properties, or 31% of properties assessed, were between 10 and 30 metres from the shoreline; and
- 39 properties, or 11% of properties assessed, were greater than or equal to 30 metres from the shoreline.

Figure 3. Main building setback ranges of all shoreline properties assessed on Peninsula Lake.

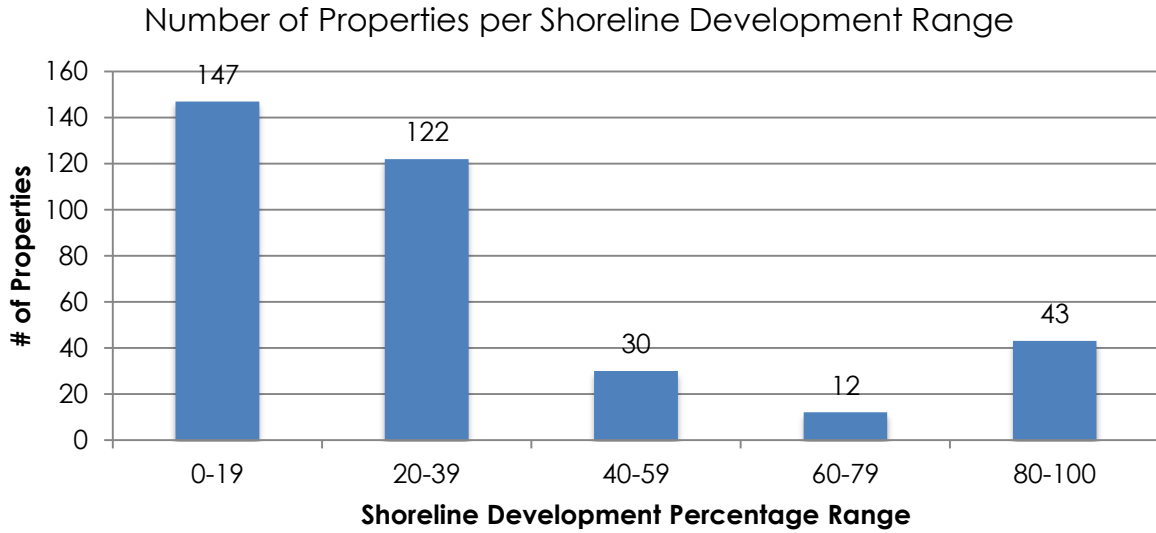
Figure 4. Shoreline development ranges per property of all shoreline properties assessed on Peninsula Lake.

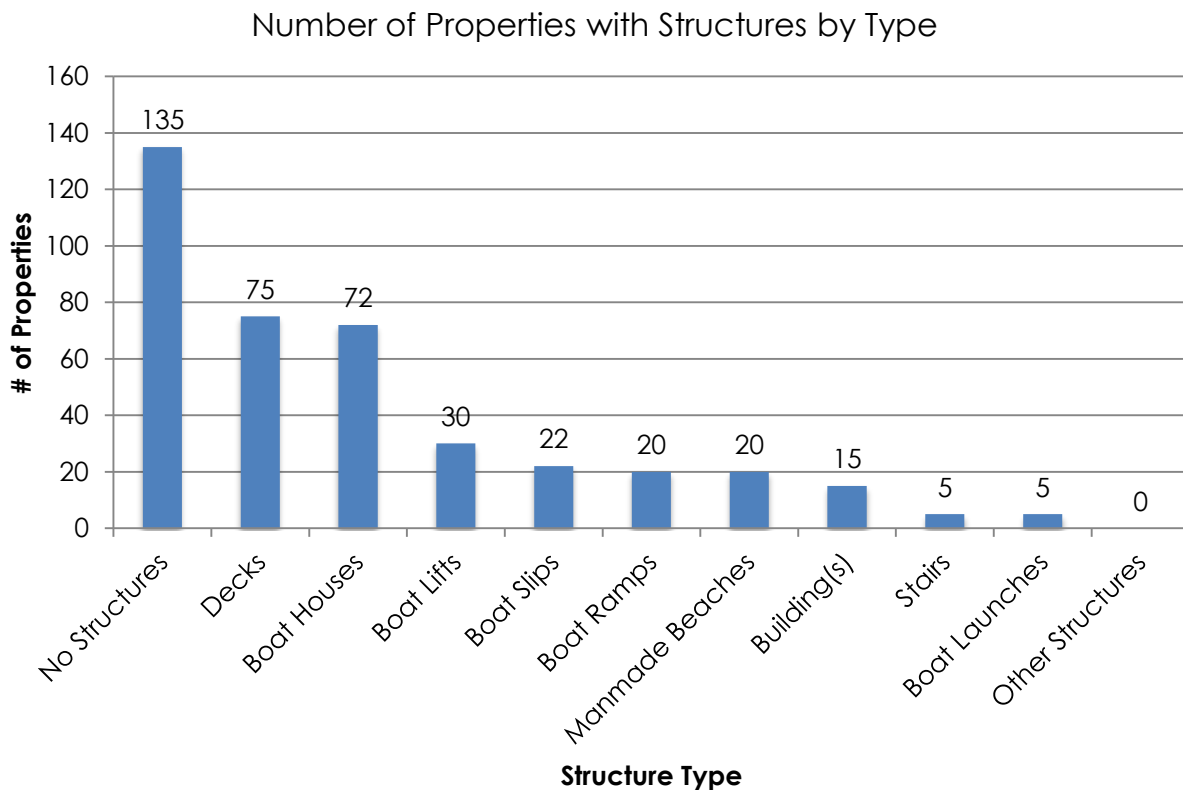
Figure 5. Shoreline development by structure type of all shoreline properties assessed on Peninsula Lake.

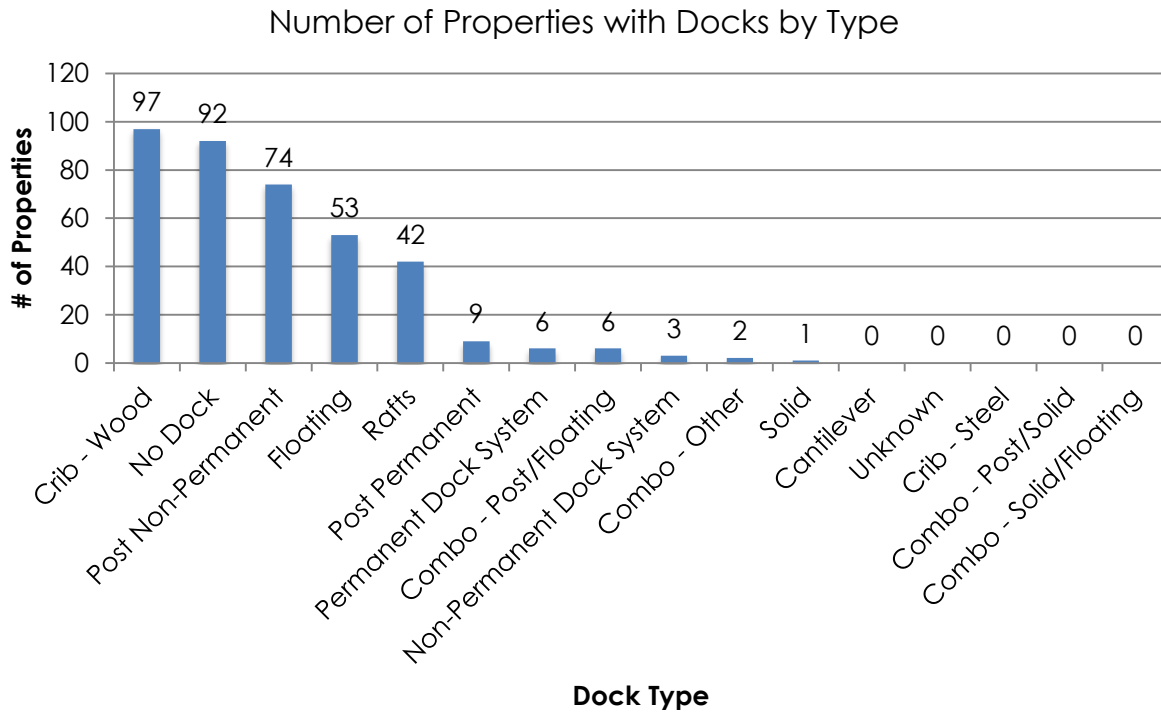
- 42 properties, or 11.86% of properties assessed, had rafts;
 - 6 properties, or 1.69% of properties assessed, had combo - post/floating docks;
 - 2 properties, or 0.56% of properties assessed, had combo - other docks

- 6 properties, or 1.69% of properties assessed, had permanent dock systems; and
 - 3 properties, or 0.85% of properties assessed, had non-permanent dock systems.

Figure 6. Types of docks of all shoreline properties assessed on Peninsula Lake.

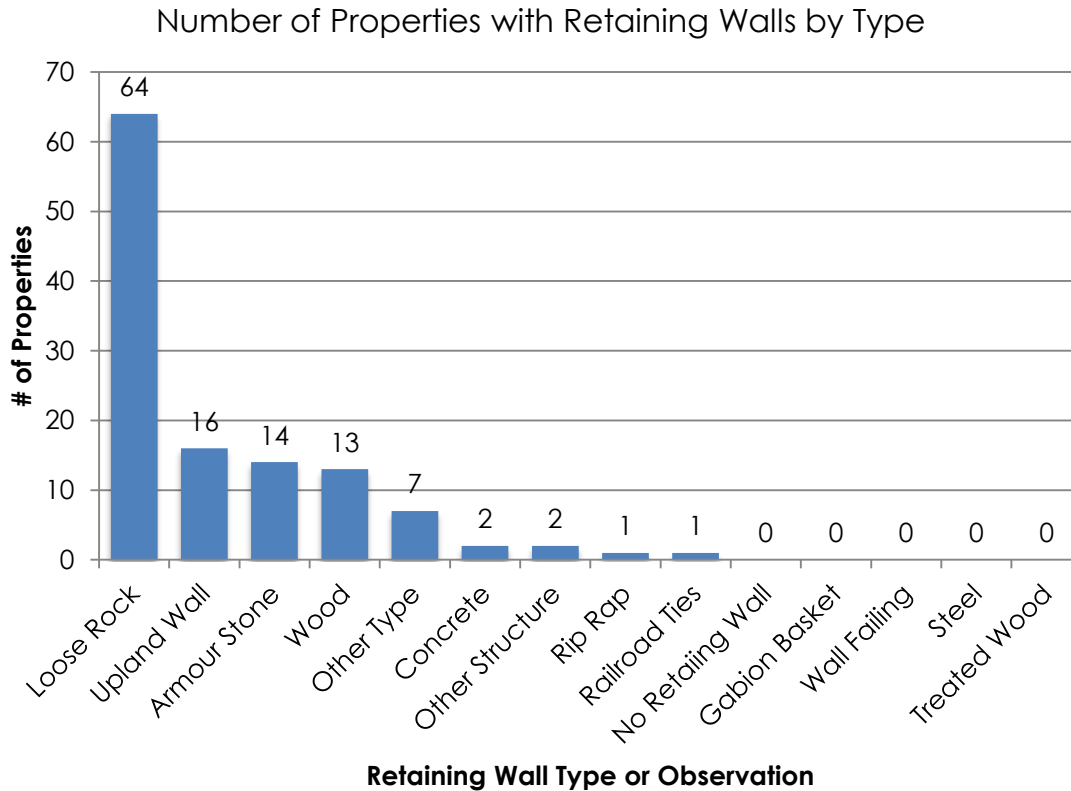
- 13 properties, or 3.67% of properties assessed, had wood retaining walls;
- 14 properties, or 3.95% of properties assessed, had armour stone retaining walls;
- 2 properties, or 0.56% of properties assessed, had concrete retaining walls;
- 1 property, or 0.28% of properties assessed, had a riprap retaining wall;
- 64 properties, or 18% of properties assessed, had loose rock retaining walls;
- 7 properties, or 1.97% of properties assessed, had other types of retaining walls; and
- 120 properties, or 66.1% of properties assessed, did not have retaining walls.

As shown in Figure 7 as well, the following numbers and percentages of properties on Peninsula Lake had retaining walls with additional observations:

- 1 property, or 0.28% of properties assessed, had railroad ties used as a wood retaining wall; and
- 16 properties, or 4.51% of properties assessed, had an upland retaining wall not on the immediate shoreline.

Figure 7. Retaining wall types and observations of all assessed properties on Peninsula Lake.

Structures made out of rock, concrete, metal and other materials were once commonly used when it was thought that the only way to combat erosion was to take a hard and aggressive approach. People began putting in concrete break walls, gabion baskets and rip-rap (loose stones along the shore). These structures do work well in the short term to prevent erosion, but they ultimately do much more harm than good.

Hardened shorelines deflect wave energy instead of absorbing it – the energy is deflected to the sides, passing the erosion problem on to neighbouring sites, and down, scouring away any sediment or plant life near the base of the wall. These structures completely obliterate the natural shoreline environment, eliminating food and habitat for creatures in and out of the water. Installing these structures requires heavy machinery, which is both costly and environmentally damaging. Worst of all, these structures eventually fail.

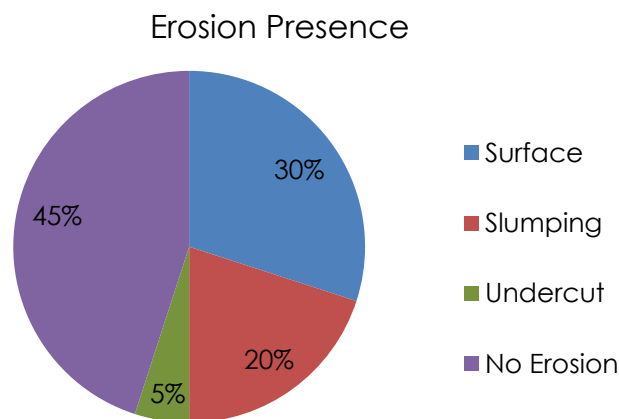
As shown in Table 3, 96 properties, or 27.1% of properties assessed on Peninsula Lake, had some form of observable erosion (including surface, mass movement/slumping, or undercut bank); and 6 properties, or 1.69% of properties assessed, had significant erosion with recommended action. Each property can have more than one type of erosion. Figure 8 shows the percentage of each type of erosion present on assessed shoreline properties on Peninsula Lake.

Figure 8. Presence of erosion observed on shoreline properties assessed on Peninsula Lake.

The best insurance policy against erosion is to retain the natural characteristics of the shoreline; this means keeping lots of vegetation, maintaining a good buffer strip (no mowing up to the water's edge) and leaving in place all of the stones, boulders, snags, and dead branches found along the shoreline. These materials absorb the energy from erosive forces like waves and keep the shoreline "glued" together.

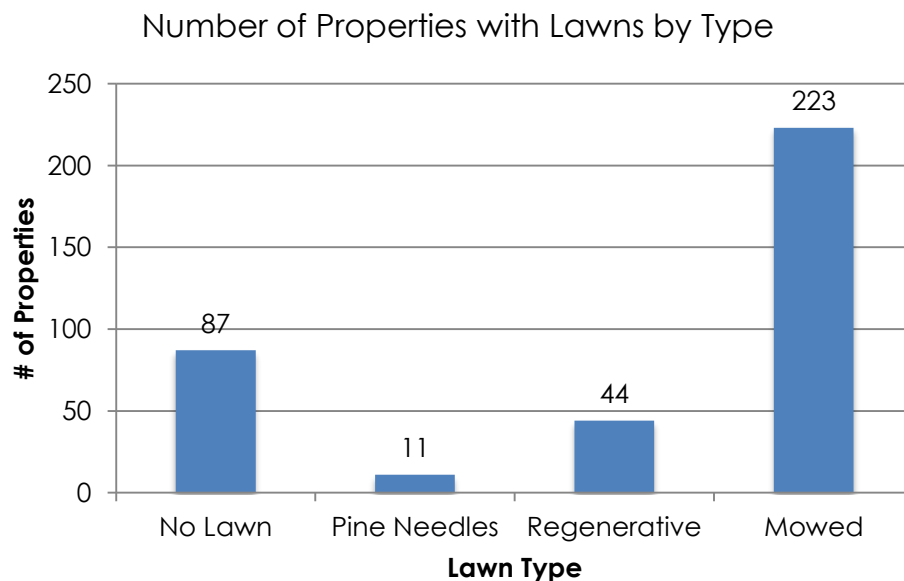
As shown in Figure 9, the following numbers and percentages of properties on Peninsula Lake had lawns, by lawn type:

- 223 properties, or 63% of properties assessed, had mowed lawns;
- 44 properties, or 12.4% of properties assessed, had regenerative lawns;
- 11 properties, or 3.1% of properties assessed, had pine needles; and
- 87 properties, or 24.6% of properties assessed, had no lawn.

Figure 9. Presence of lawns observed on shoreline properties assessed on Peninsula Lake.

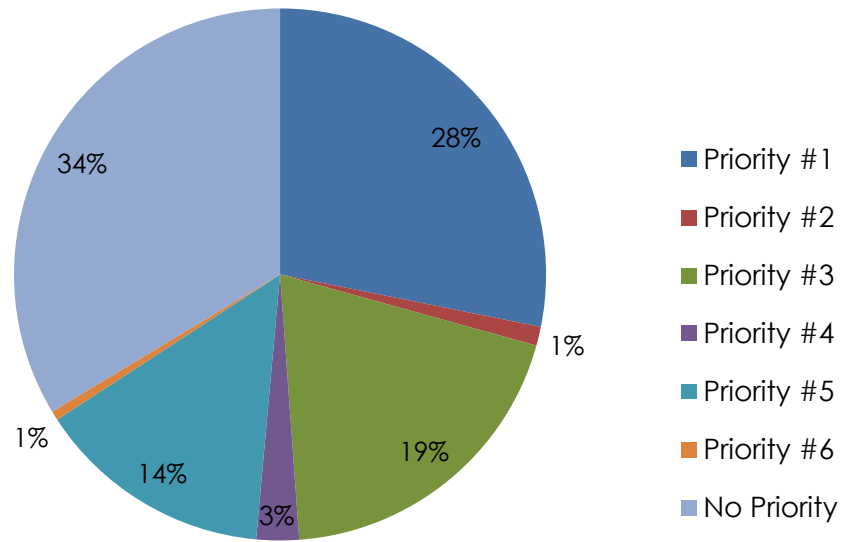
Figure 10. Naturalization priorities of all assessed properties on Peninsula Lake.
